NRL/MR/6180--04-8742

Performance of Fire Protective Coatings Subjected to DC-ARM Wartime Scenario Fires Aboard Ex-USS *Shadwell*

January 16, 2004

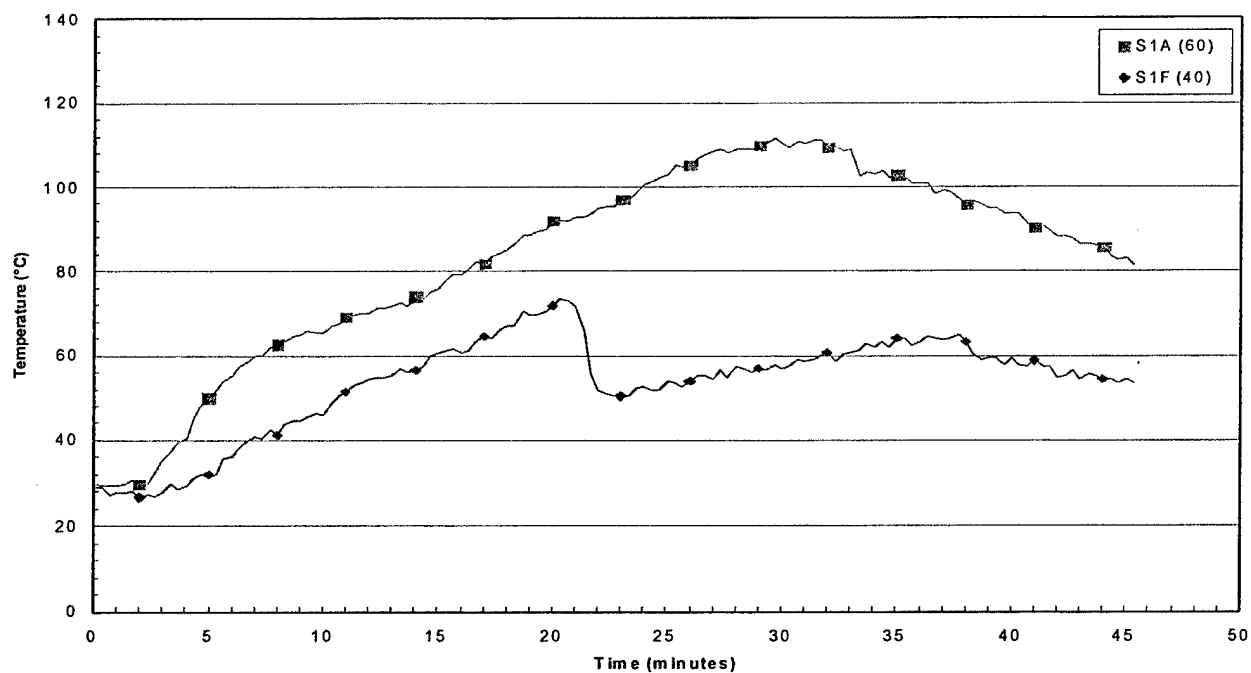
Figure 7. Temperature Profile, Panel #1

Prior to the 21-minute mark of the test, both forward and aft side, thermocouples display a nearly identical rate of increase at approximately 2 °C/min (3.7 °F/min) (Figure 7). From 23-30 minutes of the test, the aft side thermocouple continues to register a nearly identical 2 °C/min (3.7 °F/min) rate of rise while the forward side thermocouple registers a 0.4 °C/min (0.72 °F/min) rate of rise. The reduced rate of rise in forward surface temperature, beyond the 23-minute point, is further indication that a localized increase in convective cooling had occurred.

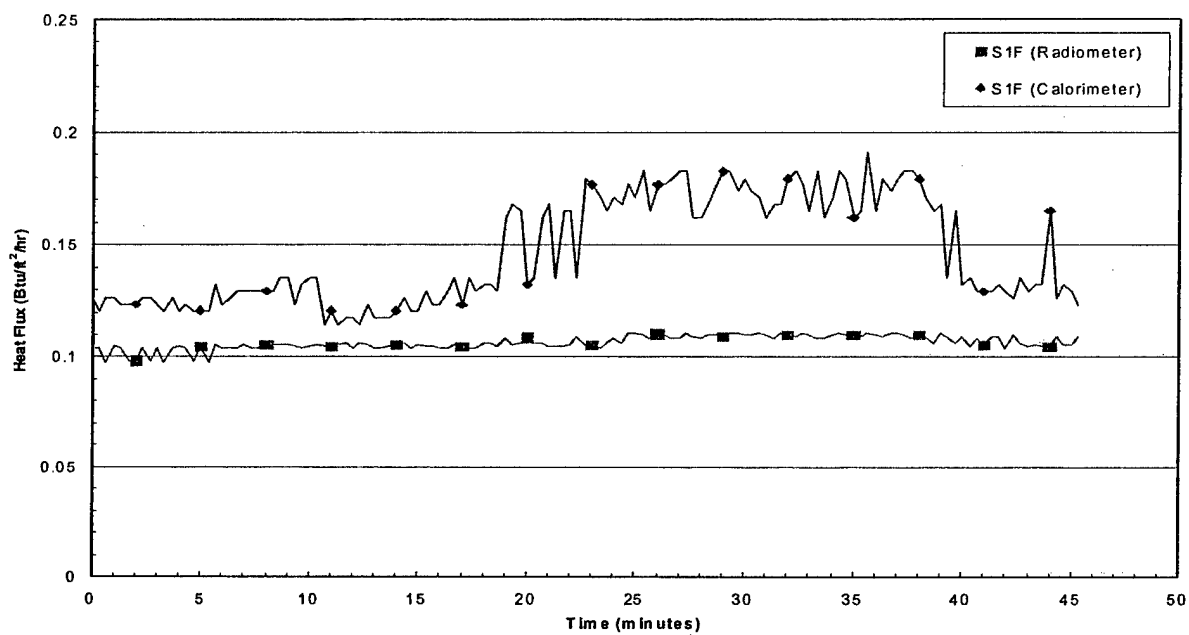
Figure 8. Heat Flux Profile, Panel #1

The upper data plot in Figure 8 is the sum of radiant and convective flux. The thermally driven velocity profile just described would have increased the convective heat transfer coefficient (h) across the forward surface of test panel 1. The increase in (h) would have increased the magnitude of the convective heat flux measured on the forward surface of this panel. This is exactly what is shown implicitly by the raw data and explicitly when equation 4 is applied to these two data traces.

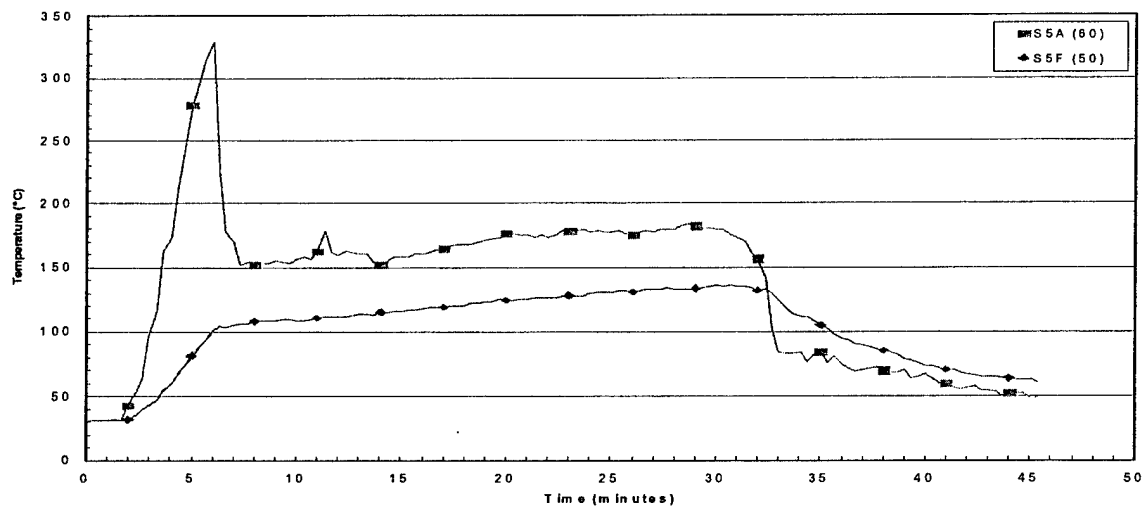
Figure 25. Temperature Profile Panel #5

Figure 25 shows the fireside bulkhead thermocouple rising rapidly from an ambient temperature of 31 °C (88 °F) to a maximum of 330 °C (594 °F) and then back to a temperature of approximately 153 °C (307 °F) in a period of approximately 6 minutes. Based on post test inspection of the coating it has been determined that the initial rate of temperature rise due to the 5 gallon heptane pool fire, approximately 75 °C/min (126 °F/min), was insufficient to activate a large scale intumescent response across the aft surface of this particular panel.

There are two possible explanations for the rapid rise and fall of the fire side surface thermocouple temperature profile (Figure 25). The first explanation is localized burning of evolved organic vapors. The second explanation is a fluctuating burn rate of the 30 cm x 76 cm (12 in. x 30 in.) heptane pool. The current understanding is that fire compartment ventilation has a measurable impact on pool burning rates, heat release rates and species production (Refs. (11) - (12)). An increase in products of incomplete combustion (smoke, CO) is some indication that there was a decrease in ventilation to the fire.

After the brief temperature "spike," the forward and aft side thermocouple exhibited a nearly identical rate of rise, 1.3⁰F/min), up to the 29 minute point in the test. The temperature

differential between aft and forward surface of this panel remained a nearly constant 49⁰C (120⁰F) from 7-29 minutes of the test.

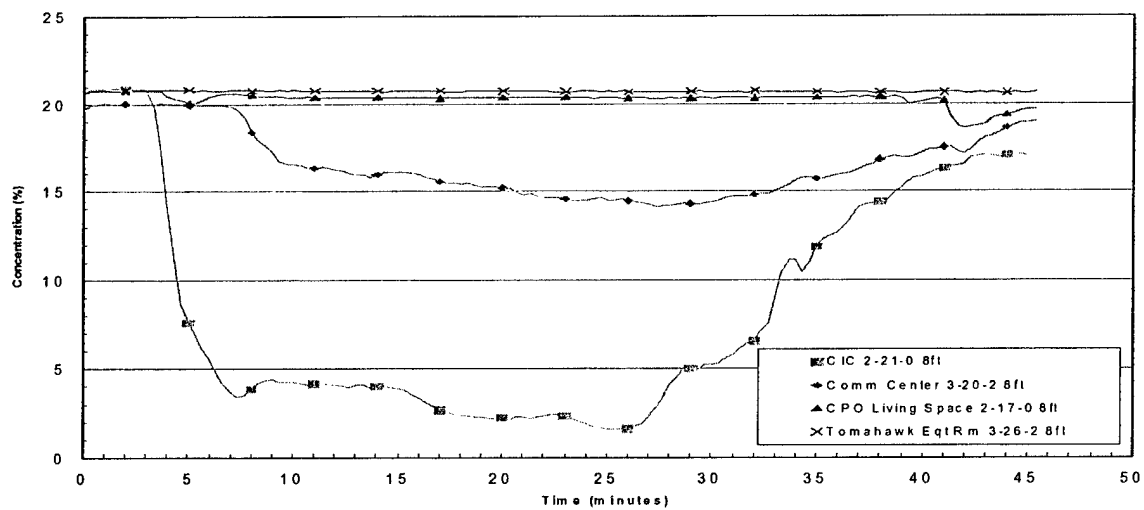
Figure 29. Oxygen Concentration Profiles

Further indication of a ventilation restricted burn can be seen in the bottom two traces of Figure 29. The sampling locations were 2.5 m (96") above the fire compartment deck and approximately 0.3 m (12") below the seats of the test fires. There were two large penetrations in the deck of the fire compartment immediately aft of the heptane pool. These large penetrations would have allowed free communication of the atmospheres between compartments 2-17-0 and 3-15-0. The oxygen measurement attributed to compartment 3-20-2 was, physically, directly below and between the seats of both test fires. The oxygen profile for the 3-20-2 location would have been, due to physical proximity alone, a close approximation of the available oxygen at the seats of these fires.

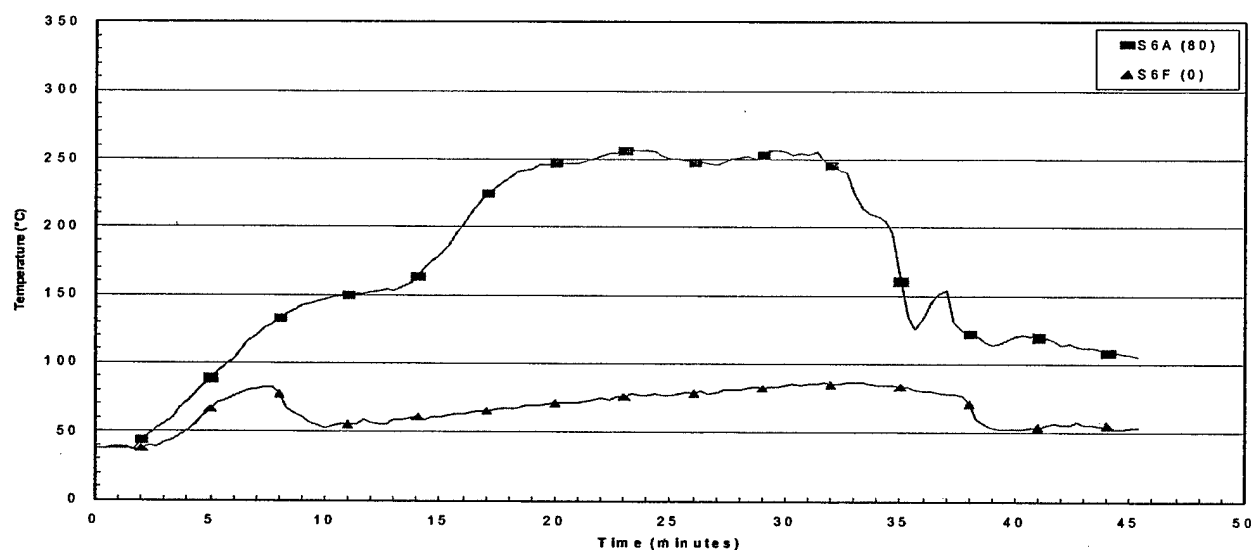
Figure 36. Temperature Profile, Panel #6

The forward side thermocouple (Figure 36) exhibits an initial rise of $6.25^{\circ}\text{C}/\text{min}$ ($11.25^{\circ}\text{F}/\text{min}$), to a maximum of 84°C (183°F) prior to the 31°C (88°F) drop in temperature at 8 minutes. After this drop the forward side thermocouple exhibits a consistent $1.5^{\circ}\text{C}/\text{min}$ ($2.7^{\circ}\text{F}/\text{min}$) rate of rise through the duration of the test. The maximum temperature differential across this bulkhead is approximately 178°C (352°F), occurring at 20 minutes into the test.

The temperature differential across this test panel (Figure 36) became significant at approximately 8 minutes into the test when the forward side thermocouple registered a 30°C (86°F) drop in temperature. Post test inspection of the panel determined that the fireside thermocouple was within the blistered region. This can be seen by close inspection of the bottom left hand corner of Figure 34. At the same time the forward surface thermocouple recorded the temperature drop, the level of radiant heat flux leaving the forward surface was recorded at a fairly stable ($0.082\text{ Btu}/\text{ft}^2/\text{hr}$) level (Figure 37). Considering the radiant flux leaving the forward side of the panel was stable during the recorded drop in temperature, it seems unlikely that loss of energy due to radiation would be the source of the observed temperature drop. In addition, the drop in temperature cannot be attributed to the previously discussed increase in free convection because the two events are separated by at least 12 minutes. The only remaining, logical, conclusion as to what influenced the measured temperature decrease, is blistering of the aft side coating.

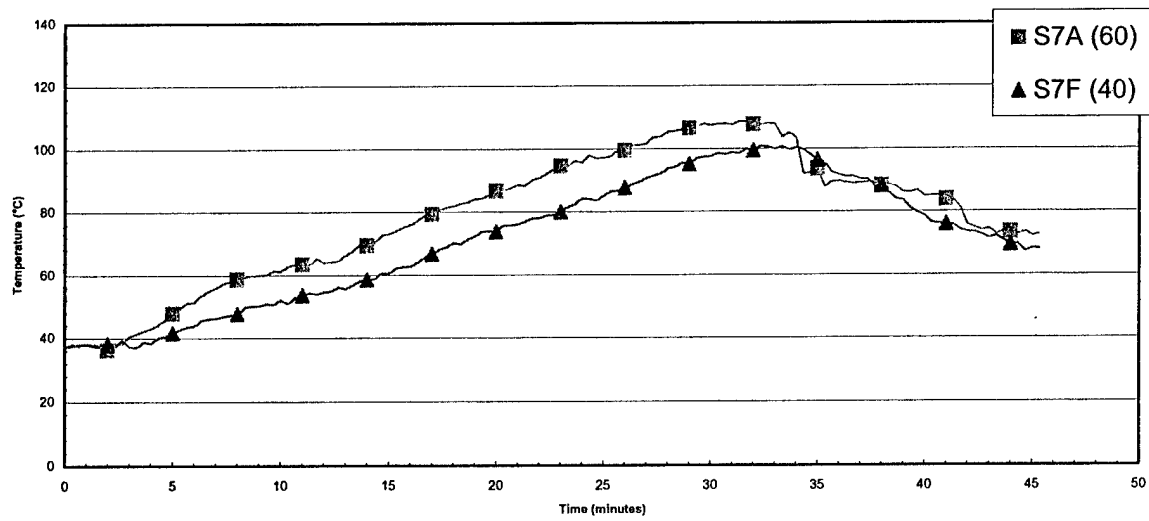
Figure 43. Temperature Profile, Panel #7, 16" Above Deck 60 Mil Fire Barrier 2-Vs. 45 Mil Temperature Coat

Figures 43-45 are temperature measurements taken at 3 different locations within the same test panel. Figure 43, measured 16" above the deck shows a nearly identical rate of temperature rise at 2.2 °C/min (3.9 °F/min) for the forward thermocouple versus 2.4 °C/min (4.4 °F/min) for the aft thermocouple. The temperature differential, at the measurement point, between the forward and aft faces of this test panel was 6°C at 5 minutes, 15 °C at 17 minutes and 12 °C at 29 minutes.

The bottom traces of Figure 43 and Figure 44 show there was little apparent benefit to application of the Temp Coat product. The maximum surface temperatures on the Temp Coat treated forward side of panel 7 (Figures 43 and 44), were not significantly different than those

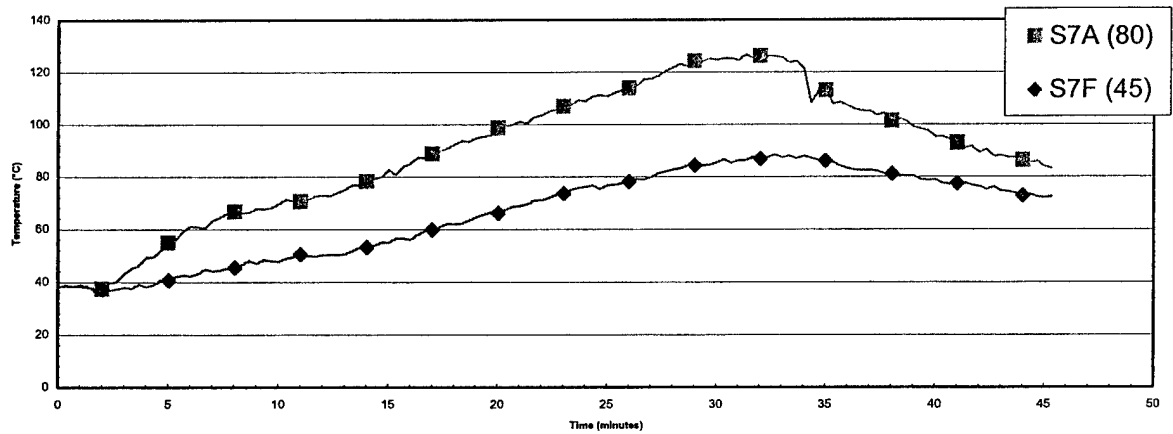
Figure 44. Temperature Profile, Pane #7, 27" Above Deck 80 Mil Fire Barrier-2 Vs. 45 Mil Temperature Coat

Figure 44, measured 27" above the deck, shows the fireside bulkhead temperature rising at an average of 2.9 °C/min (5.3 °F/min) while the forward side temperature rises at 1.8 °C/min (3.2 °F/min). The temperature differentials were 13 °C (55 °F) at 5 minutes, 30 °C (86 °F) at 18 minutes and 40 °C (104 °F) at 29 minutes.

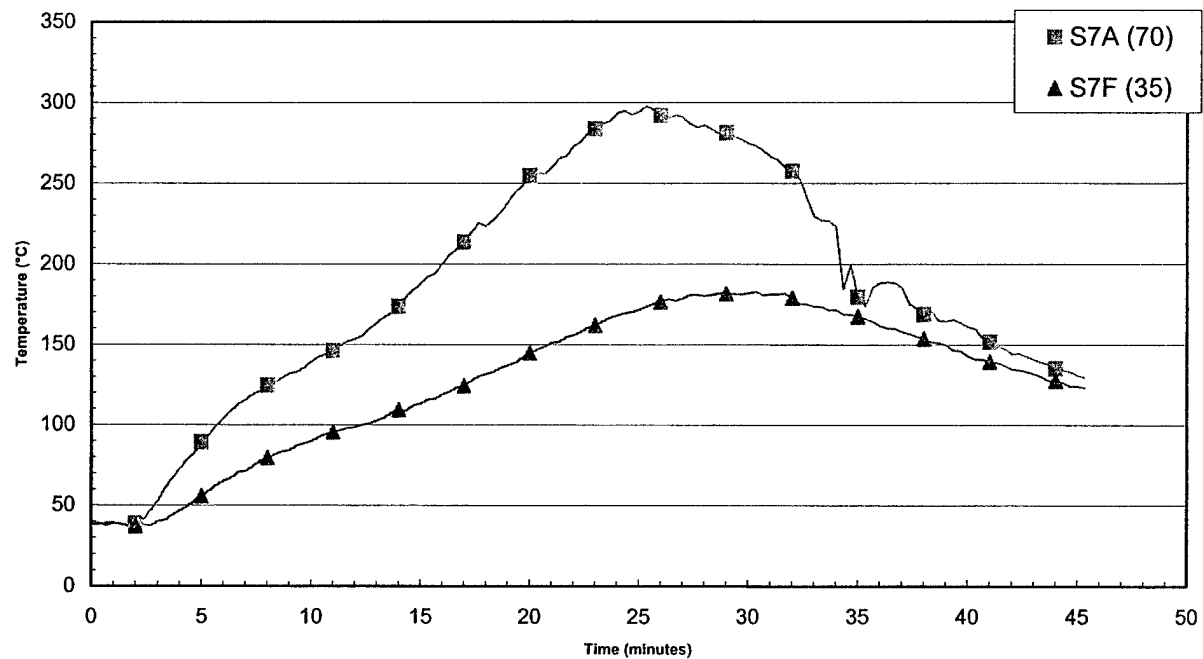
Figure 45. Temperature Profile, Panel #7, 66" Above Deck 70 Mil Fire Barrier-2, Vs. 35 Mil Temperature Coat

Figure 45, measured at 66" above the deck, shows the fireside thermocouple temperature rise being 10.9 °C/min (19.6 °F/min) while the forward side rise is 6 °C/min (10.8 °F/min). The temperature differentials were 33 °C (91 °F) at 5 minutes, 75 °C (167 °F) at 15 minutes and 126 °C (259 °F) at 24 minutes.
